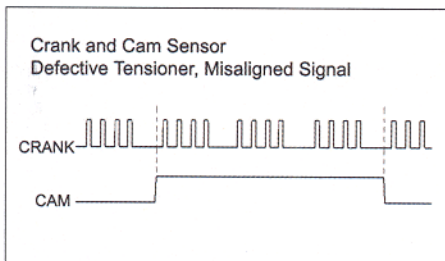
Figure 1: After hooking up the scope to the two sensors, we found that the automatic tensioner was indeed defective.

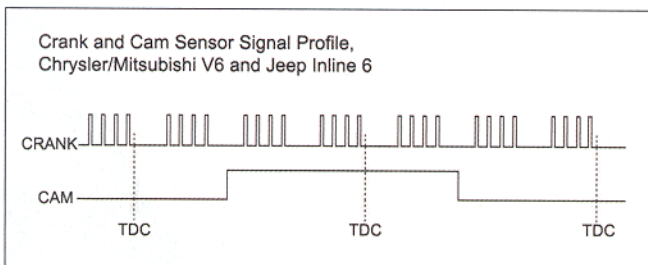
Figure 2: The signals used in the Chrysler applications of Mitsubishi's V6 use the same crank and cam sensor profiles as the Jeep in-line six cylinder engines.
